Motor Vehicle Safety
 Information: 1-800-333-0371

Ferrari Befix High Back Booster Seats – Shoulder Belt Guide Routing Instruction
 Revisions

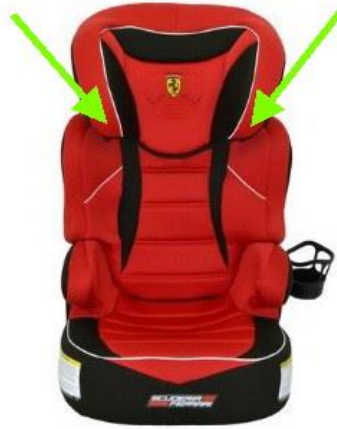
Figure 1. Location of the Shoulder Belt Guides

5514 KM Corporation and Transport Canada wish to inform the public about the availability of revised instructions for certain Ferrari Befix high back booster seats. These booster seats were available in two different shoulder belt guide configurations, either with a simple U-shaped slot or with a Z-shaped slot. The shoulder belt guides are located on the underside of the booster seat’s head support and help to properly position the vehicle shoulder belt across the child occupant’s chest and collarbone.

It is possible that the labels affixed to, and the English and French instruction manuals provided with the booster seats did not outline the proper shoulder belt guide configuration. Without the correct instructions, it may be possible to have the vehicle shoulder belt routed incorrectly, preventing the belt from sliding freely in the guide. The revised instructions clarify the correct routing of the vehicle shoulder belt through the shoulder belt guide. Transport Canada’s defect investigations program identified this issue after receiving a consumer complaint.

5514 KM Corporation has revised the instruction page to ensure that the instructions clearly describe the vehicle shoulder belt routing process.
